Sewer Sense

FREMONT GROWS WITH A PROVEN WINNER

WET, RUNNING SAND No Problem for VCP

HOW ONE SANITARY DISTRICT TURNED A LIABILITY INTO AN ASSET

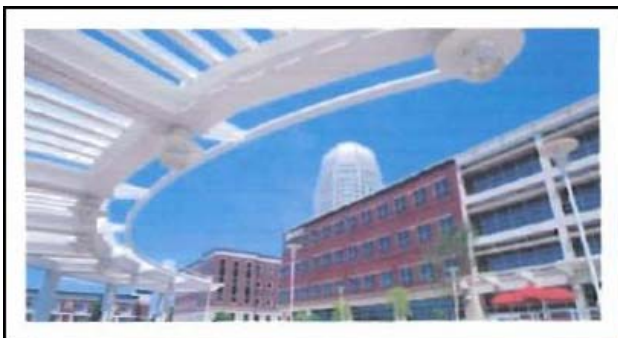
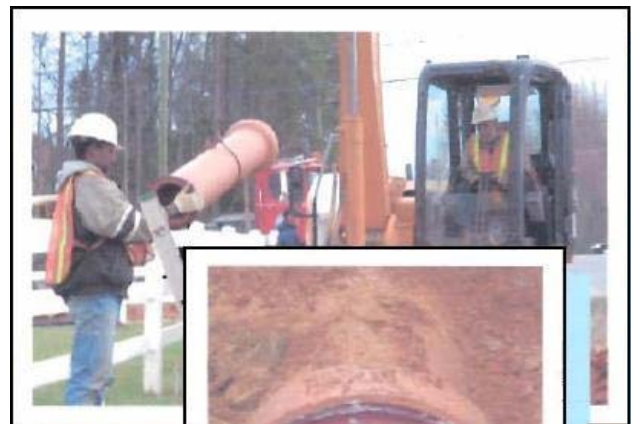
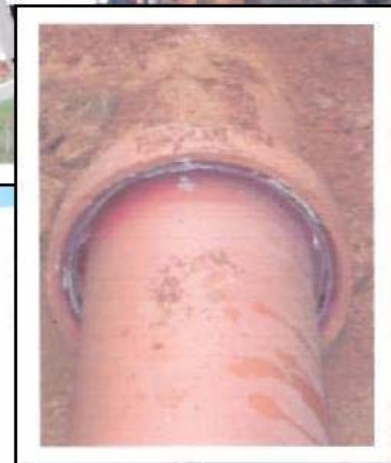
The extremely wet conditions required the extensive use of pumps to remove ground water for installation. A majority of the project was in running sand. Despite these difficult conditions, all the pipe easily passed the required air tests. The project was completed well within the 270-day contract time with the contractor averaging 200 ft. per day of pipe installation.
